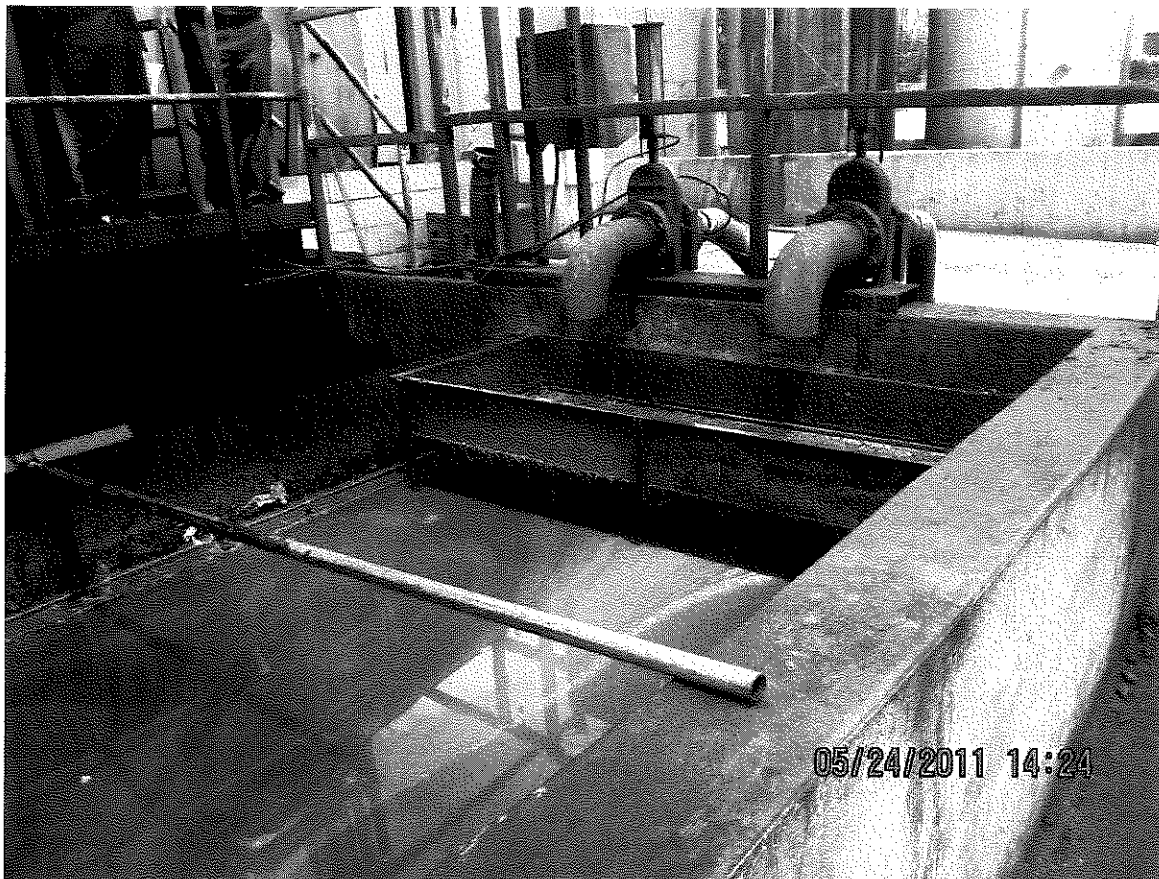
Photograph 1 of 14. Receiving pit with screen. M. Mikulka, U. S. EPA, LCD, 05/24/11, 1424 hrs, Cannon SD1400IS, Ser. No., 212065043412, digital media.

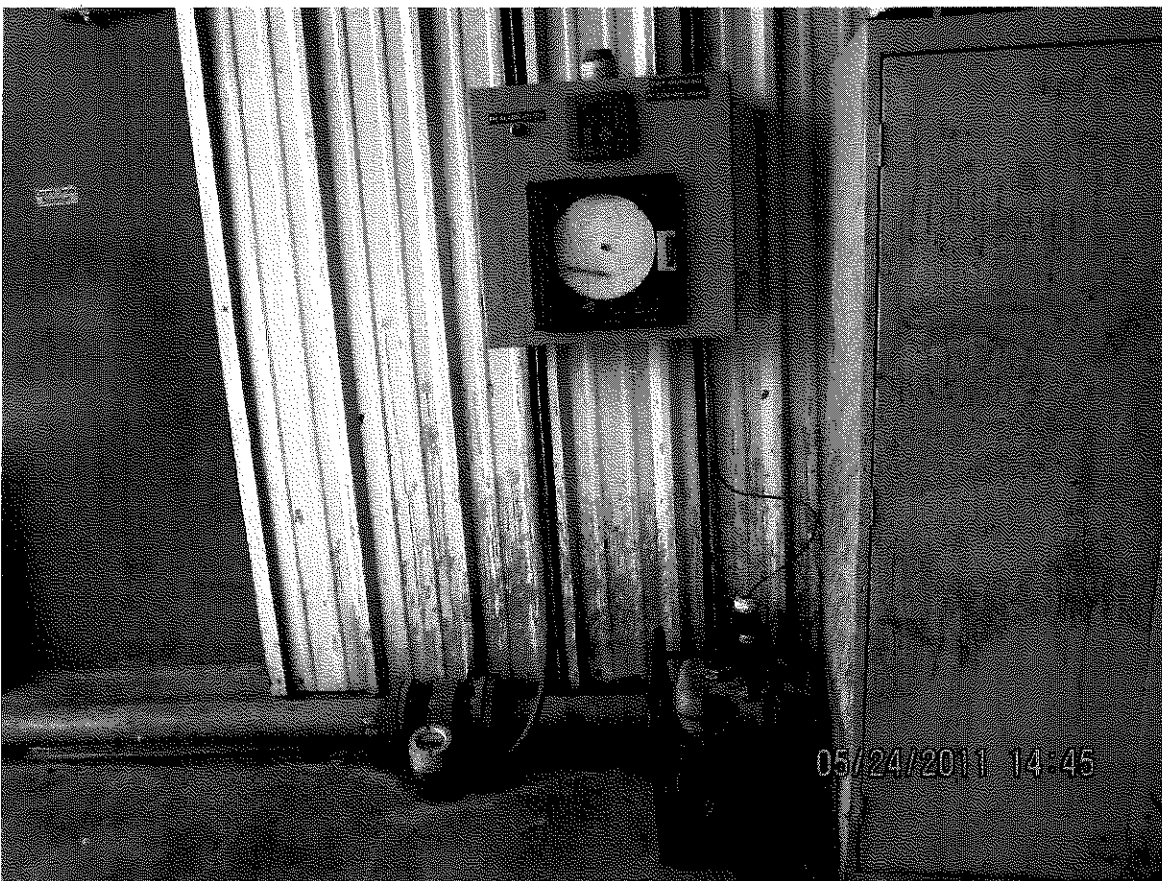
Photograph 4 of 14. Flow meter (on floor by pipe) for discharge to city sewer. pH meter recorder on wall. M. Mikulka, U. S. EPA, LCD, 05/24/11, 1445 hrs, Cannon SD1400IS, Ser. No., 212065043412, digital media.
